**NASA Technical Memorandum 78926**

# **ULTRAVIOLET IRRADIATION AT ELEVATED TEMPERATURES AND THERMAL CYCLING IN VACUUM OF FEP-A COVERED SILICON SOLAR CELLS**

TECHNICAL PAPER presented at the  
Thirteenth Photovoltaic Specialists Conference  
sponsored by the Institute of Electrical and Electronics Engineers  
Washington, D.C., June 5-8, 1978

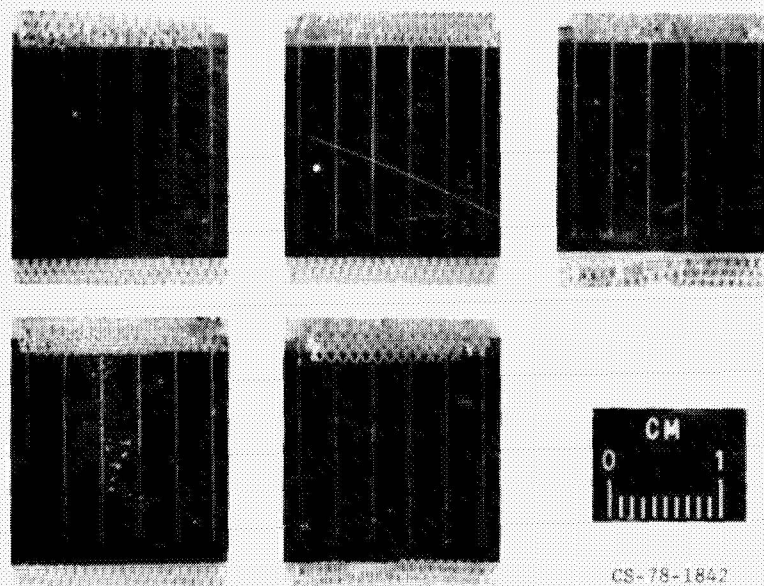
Figure 2.

| Description of sample | Temp. during UV irradiation, °C | Number of samples | Number of thermal cycles before onset of damage | Number of samples damaged | Extent of damage |
|---|---|---|---|---|---|
| Heat-bonded FEP-A | 30-35 | 15 | 70 | 3 | Very slight cracking and indication of blisters after 70 cycles. |

UV (30<sup>0</sup>-35<sup>0</sup> C)/70 THERMAL CYCLES (-130<sup>0</sup> + 130<sup>0</sup> C)

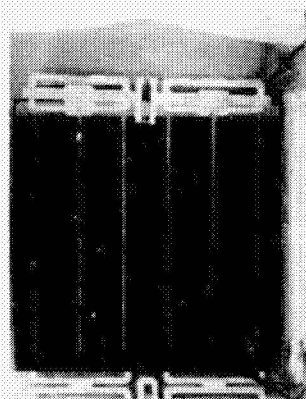
Figure 3.

| Description of sample | Temp. during UV irradiation, °C | Number of samples | Number of thermal cycles before onset of damage | Number of samples damaged | Extent of damage |
|---|---|---|---|---|---|
| Heat-bonded FEP-A | 55-75 | 2 | 26 | 2 | Wide cracks after 26 cycles; Severe cracking and blistering after 70 cycles. |

# HEAT-BONDED FEP COVER TEST UV (55<sup>0</sup>-75<sup>0</sup> C)/70 THERMAL CYCLES (-130<sup>0</sup> + 130<sup>0</sup> C)

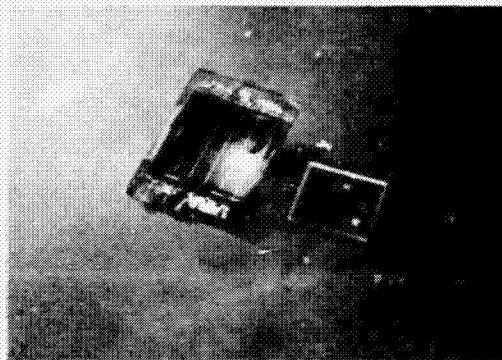
Figure 5

In contrast, the adhesive bonded FEP-A covers, showed a partial separation from the surface of the cells but no cracking (fig. 5). This suggests that the cracking of the cover and subsequent proton damage to the cells might be avoided with an optimized adhesive bonding technique. Lower temperature cover application would be beneficial since it avoids possible built in stresses, and the possibility of changes in the FEP-A, that could occur during heat bonding.

| Description of sample | Temp. during UV irradiation, °C | Number of samples | Number of thermal cycles before onset of damage | Number of samples damaged | Extent of damage |
|---|---|---|---|---|---|
| Adhesive-bonded FEP-A | 85-105 | 2 | 11 | 2 | Partial separation from surface of cell after 11 cycles; no cracking after 70 cycles. |

ADHESIVE BONDED FEP COVER TEST  
UV (85<sup>0</sup>-105<sup>0</sup> C)/70 THERMAL CYCLES (-130<sup>0</sup> + 130<sup>0</sup> C)
